Manhole Inspection Summary

Manhole # S71S__012MH

Insp Date: **4/10/08 10:51 AM**

Location Address: **6713 Roberts Ave.**

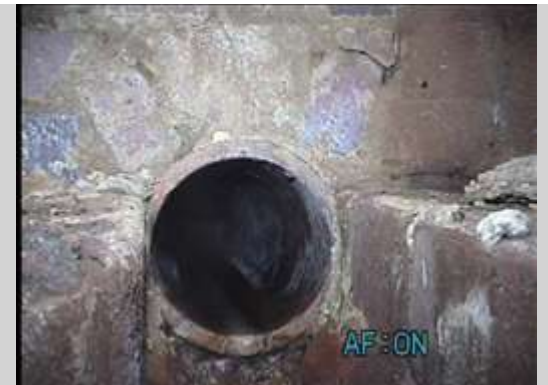
3 O'Clock Inflow

6 in. Circular Gravity Sewer
Pipe In @ 3 O'Clock

Pipe Height: **6** (in.) Rod and Bar (Angled)
Pipe Material: **Clay** ☐ Pipe Lined
Invert Depth: **7.00** (ft.) Flow Characteristics: **None**
Deposits: ☒ None ☐ Mud ☐ Sludge ☐ Debris ☐ Grease
Silt Depth: (in.) Deposits Extent:
Infiltration: **None** Pipe Seal Cond: **Sound**

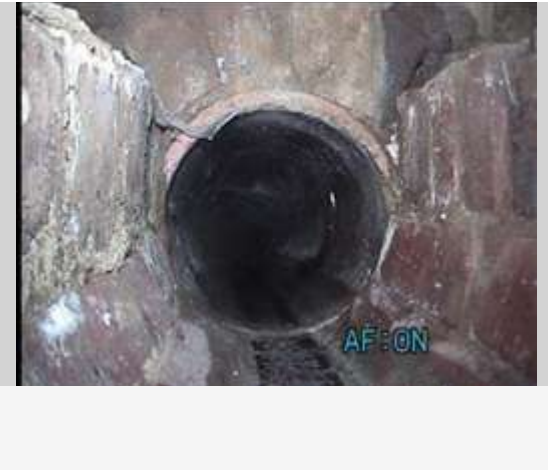
6 O'Clock Inflow

8 in. Circular Gravity Sewer

Pipe In @ 6 O'Clock

Infiltration: **None** Pipe Seal Cond: **Sound**
